### Replacement of Bollards and Additional Terminal Investigations

Client: Puma Energy  
Location: Canal di Vridi  
Period: November 2009 to March 2010

#### Replacement of 4 x No 50 tons Bollards with 100 tons and Additional Terminal Investigations of Petroleum Terminal, Canal di Vridi, Port of Abidjan, Ivory Coast

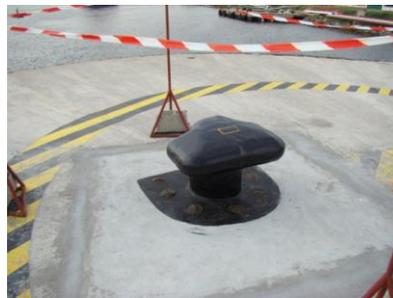
A 2mx2mx1.1m excavation was done by breaking the concrete with a compressor and a hammer. Care was taken not to damage the existing rebar. The new 100 ton bollard was secured in place and installed. C45 premix concrete was used. Cement solution and Sika Latex chemical was applied on the excavated face to ensure proper bonding between the old concrete and the new one.

PMI prepared a method statement for the replacement of all 4 x 50 ton bollards with 100 ton. PMI mobilized to the site for the replacement of the failed 50 ton bollard with a new 100 ton after which the contractor continued with the replacement of the other three, with PMI managing affairs.

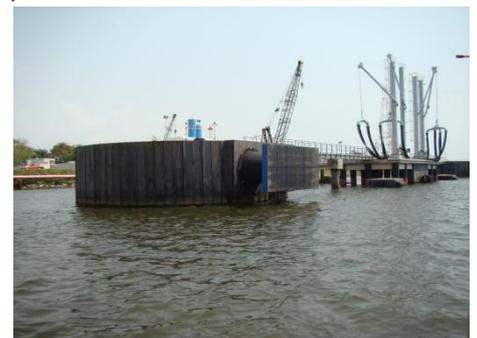
Analysis of the loading platform however, indicated that it had limited resistance laterally with significant horizontal displacement. PMI therefore recommend stiffening the lattice structures between the loading platform and the caissons.
